Shell Aircraft Safety Moment

RPAS Hard Landing Incident – Falcon Pipeline Right of Way

Todd Chase
Shell Aircraft

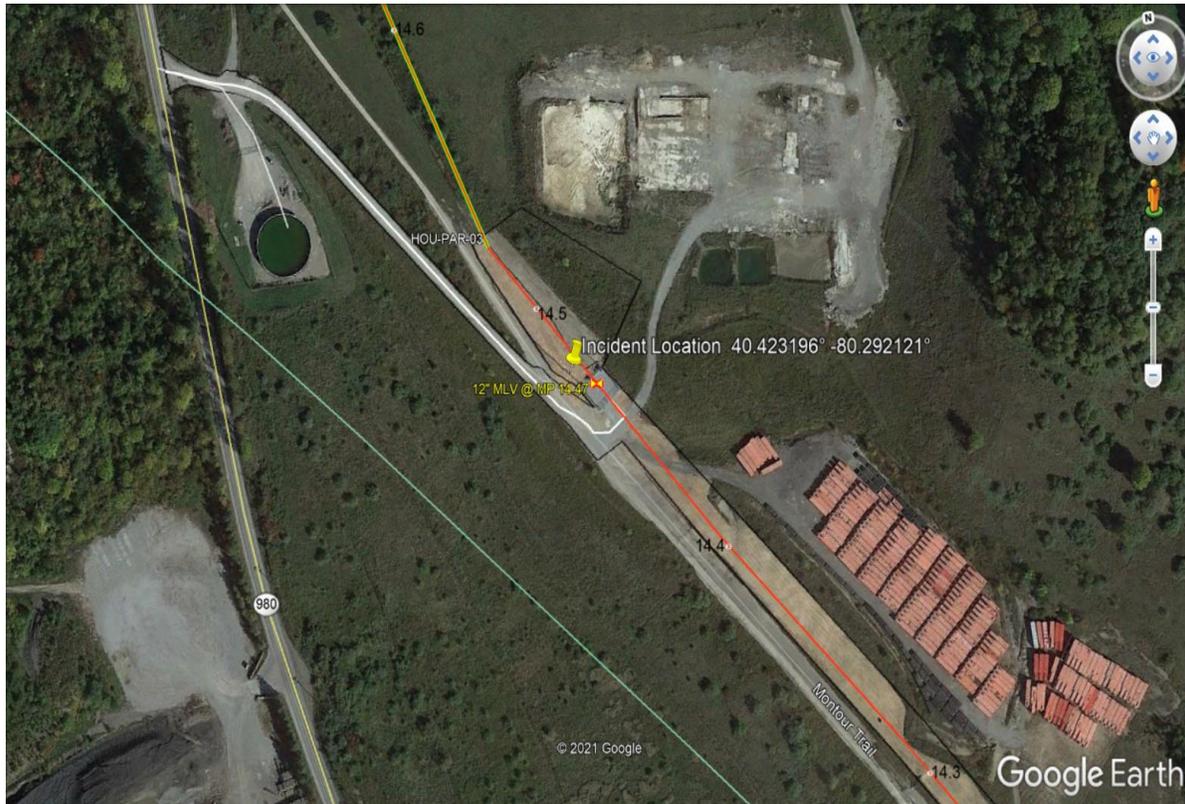
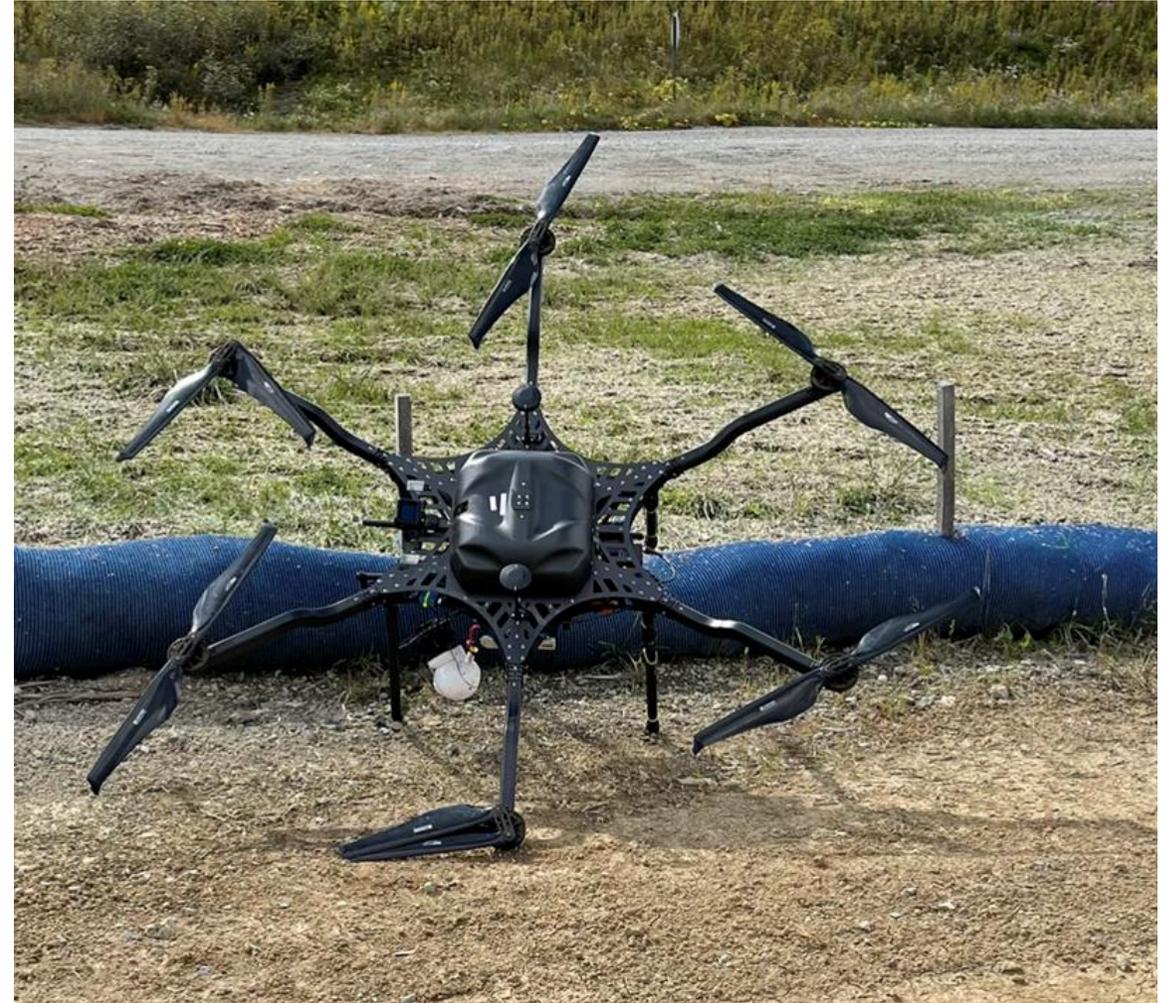
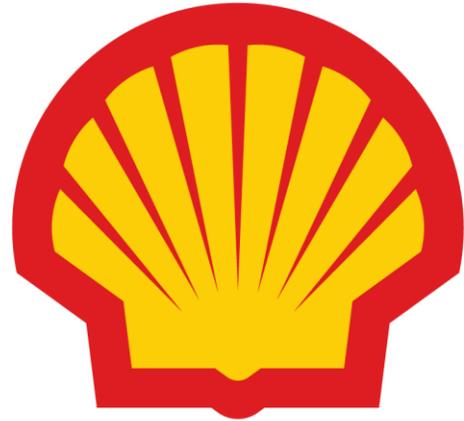
- During automated flight on an aerial patrol support SPLC, the PIC of the Harris Aerial H6 aircraft lost command link(C2) to the RPA.
- The aircraft continued on it's programmed flight path and remained in a hover until fuel starvation. The back-up batteries quickly lost power and the aircraft enter a rapid descent.
- Damage occurred to the aircraft carbon fiber structure and the FLIR ball dislodged from the mounting bracket. A power line was contacted during the descent, but no damage occurred to the line.

- The RPAS Operator's investigation found that there was no back-up C2 link and the low-voltage override switch had been disconnected among others. The switch commands the aircraft to begin a gradual descent at a minimum voltage level. The link was initially disabled as a result of earlier missions with high winds and a heavy payload initiating un-commanded descents during.
- The RPAS C2 Link was disabled due to the back-up radio not being installed after maintenance. Perceived pressures from a COVID related delay and mission timeliness requirements resulted in operator making decision to operate without the redundancy in C2.

- Unintended consequences from aircraft alterations made to the RPAS without consultation with OEM resulted in the hard landing.
- RPAS OEM airworthiness and reliability processes and procedures are often in-mature and underdeveloped when compared with traditional aviation OEMs.
