Shell Aircraft Safety Moment

RPAS Hard Landing Incident – Falcon Pipeline Right of Way

Todd Chase
Shell Aircraft

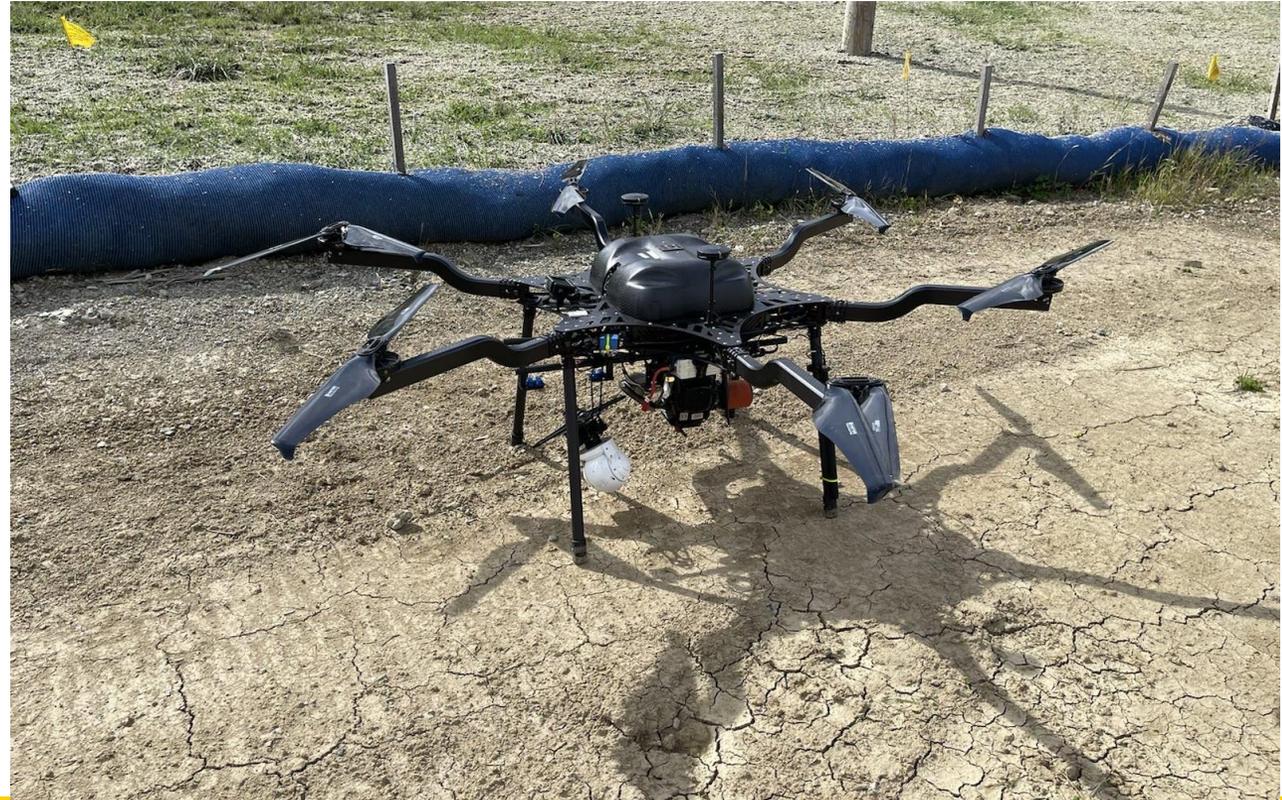
- During automated flight on an aerial patrol support SPLC, the PIC of the Harris Aerial H6 aircraft lost command link(C2) to the RPA.
- The aircraft continued on it's programmed flight path and remained in a hover until fuel starvation. The back-up batteries quickly lost power and the aircraft enter a rapid descent.
- Damage occurred to the aircraft carbon fiber structure and the FLIR ball dislodged from the mounting bracket. A power line was contacted during the descent, but no damage occurred to the line.

- The RPAS Operator's investigation found that there was no back-up C2 link and the low-voltage override switch had been disconnected among others. The switch commands the aircraft to begin a gradual descent at a minimum voltage level. The link was initially disabled as a result of earlier missions with high winds and a heavy payload initiating un-commanded descents during.
- The RPAS C2 Link was disabled due to the back-up radio not being installed after maintenance. Perceived pressures from a COVID related delay and mission timeliness requirements resulted in operator making decision to operate without the redundancy in C2.

- Unintended consequences from aircraft alterations made to the RPAS without consultation with OEM resulted in the hard landing.
- RPAS OEM airworthiness and reliability processes and procedures are often in-mature and underdeveloped when compared with traditional aviation OEMs.
